## MARINE INVESTIGATION REPORT

M99M0161

### CAPSIZING AND SINKING WITH LOSS OF LIFE

THE FISHING VESSEL "WET N' WILD II"  
MALPEQUE BAY, PRINCE EDWARD ISLAND  
1 DECEMBER 1999

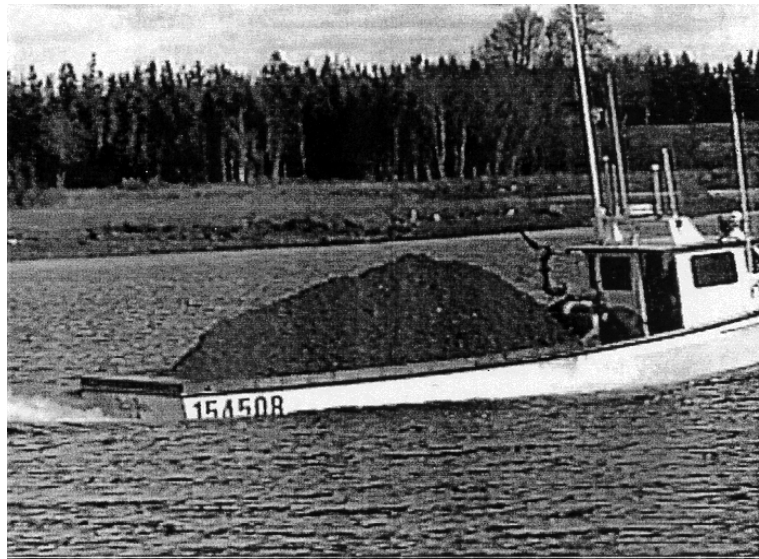
The "WET N' WILD II" with a typical load.  
30 November 1999

The dredged material was loaded onto the platform deck in a long pile about 1 m to 1.2 m high. The exact weight of the deck cargo was not recorded. A 0.016 m<sup>3</sup> sample of the cargo weighed 15.4 kg. Assuming that the pile on deck was prism-shaped, with sloping ends and sides, and having a volume of approximately 8.7 m<sup>3</sup>, the cargo is estimated to have weighed approximately 8347 kg. The platform and its attachments, plus the portable pump, are estimated to have weighed a further 1000 kg. The estimated vertical centre of gravity of the cargo would have been about 0.53 m above the gunwale.
